Manhole Inspection Summary

Manhole # S51K__051MH

Location Address: **2935 Fait ave**

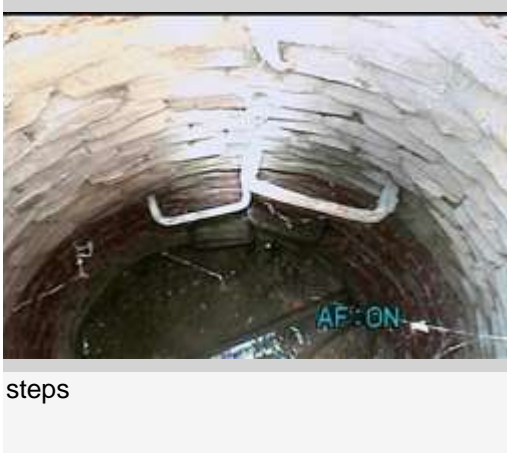
Defect 5

Count: **5** Missing: **1** ☒ **Corroded**

steps

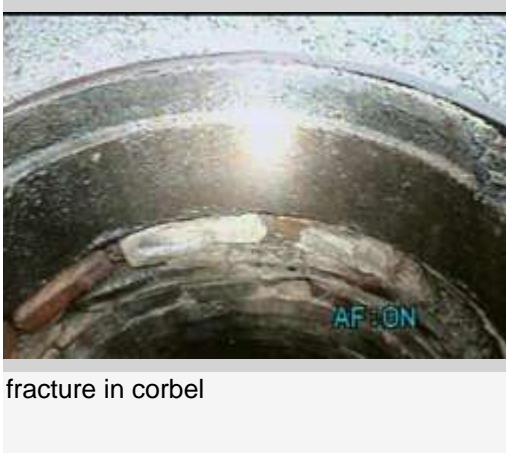
Defect 4

Condition: ☐ Sound ☒ **Cracked** ☐ Root Intrusion ☐ Loose Brick ☐ Deteriorated

fracture in corbel

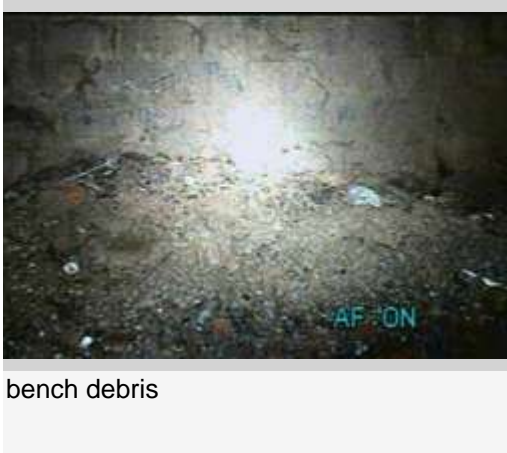
Defect 3

Condition: ☐ Sound ☐ Cracked ☐ Root Intrusion ☐ Deteriorated ☐ Leaks ☒ **Debris**

bench debris

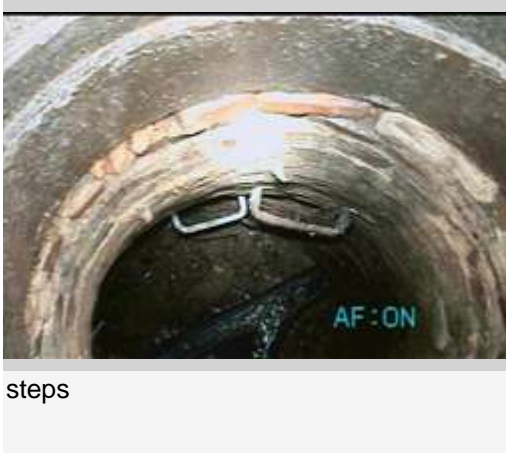
Defect 2

steps

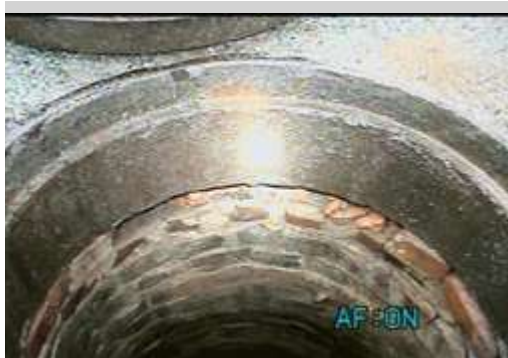
Defect 1

Condition: ☐ Sound ☐ Cracked ☐ Root Intrusion ☒ **Loose Brick** ☒ **Deteriorated**

Loose Bricks and Deterioration in Chimney

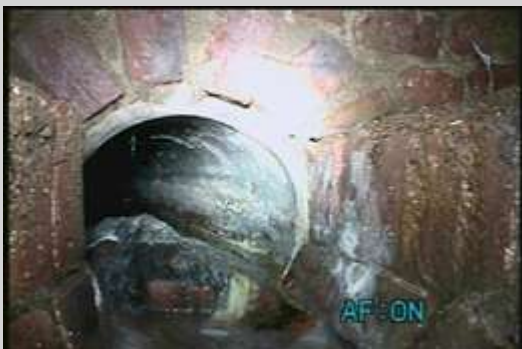
3 O'Clock Inflow

Deposits: ☐ None ☐ Mud ☐ Sludge ☒ **Debris** ☐ Grease

Silt Depth: 3 (in.) Deposits Extent: **Light**

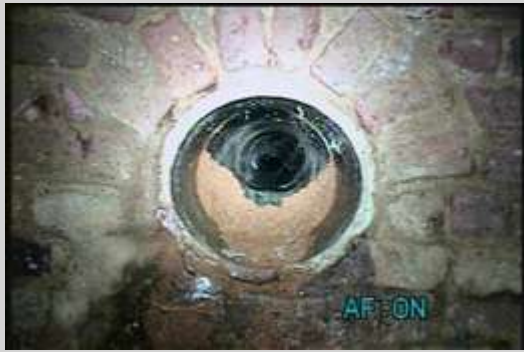
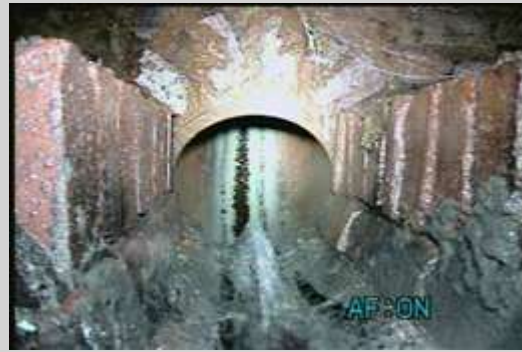
6 O'Clock Inflow

Drop: **Outside** **Direct**

Drop Condition: **Partly Clogged**
